**THAMES RIVER BASIN  
COVENTRY-MANSFIELD, CONNECTICUT**

**EAGLEVILLE LAKE DAM  
CT 00161**

**PHASE 1 INSPECTION REPORT  
NATIONAL DAM INSPECTION PROGRAM**

**JUNE 1979**

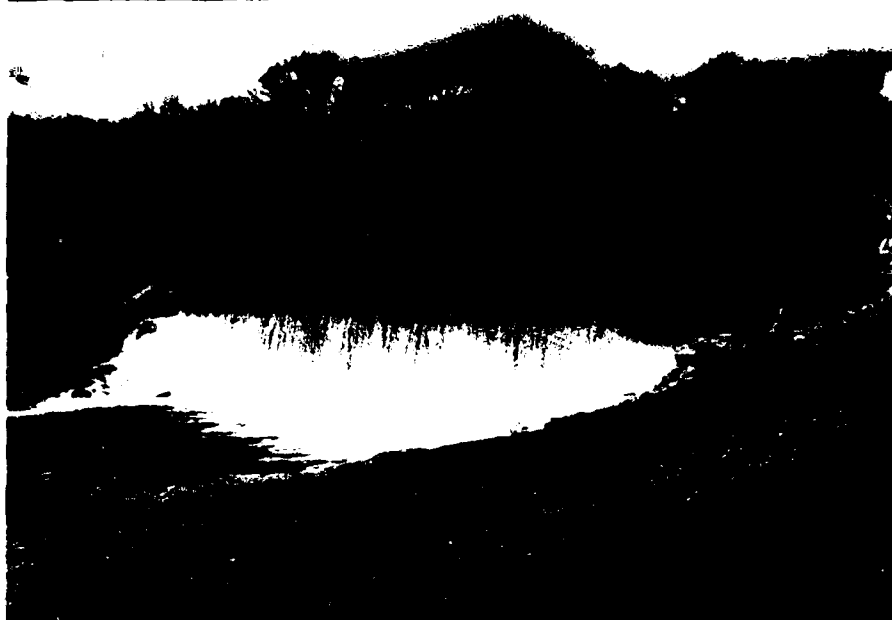
ing (foreground of Photo C-1). Grass cover is largely missing and the slope is rutted with numerous vehicular tracks up to 6 inches deep. An erosion gully about 2 feet wide was observed adjacent to the left spillway training wall, shown in Photo C-1 near the spillway and in C-11 downstream of the spillway. Several large bushes are growing in one area of the slope.

C-1 Spillway from left side of channel.

4. Repair erosion gullies and install cover material to prevent further erosion on dam embankment crest and downstream slope.
  5. Repair the concreted riprap at the right spillway abutment.

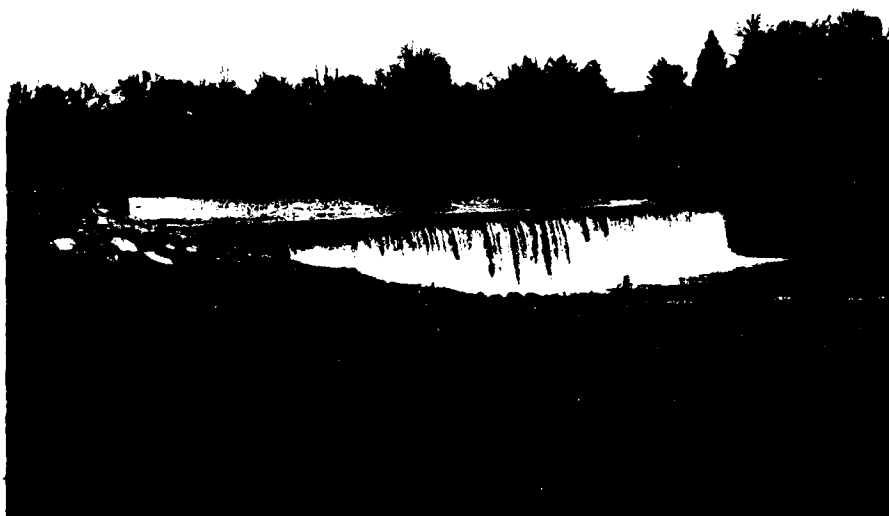
To the right of the spillway, the downstream slope is extremely gentle, grass covered and reasonably well-maintained, as shown in Photo C-2. The downstream end of the concreted-riprap apron at the right end of the spillway is cracked and broken, and erosion is occurring along the downstream edge of the apron, as shown in Photo C-10.

C-2 Spillway from right side of channel.

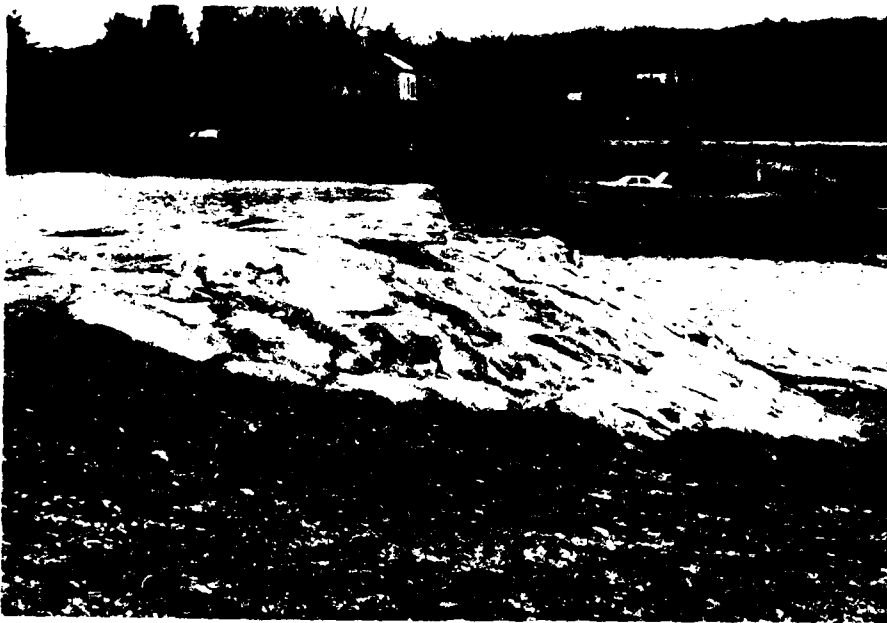
C-4 Left spillway abutment (background) and mortared riprap around right spillway abutment (foreground).

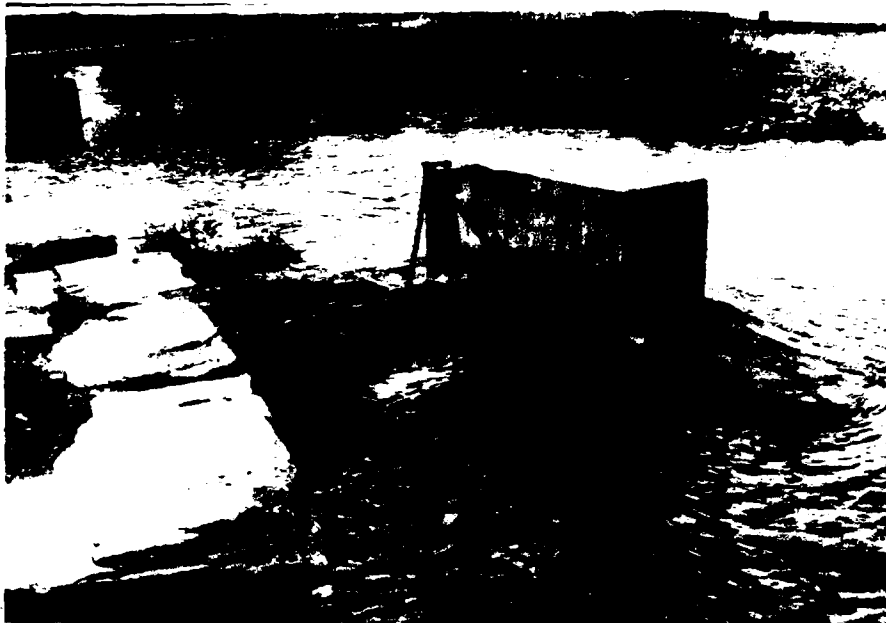
C-5 Outlet works from intake side.

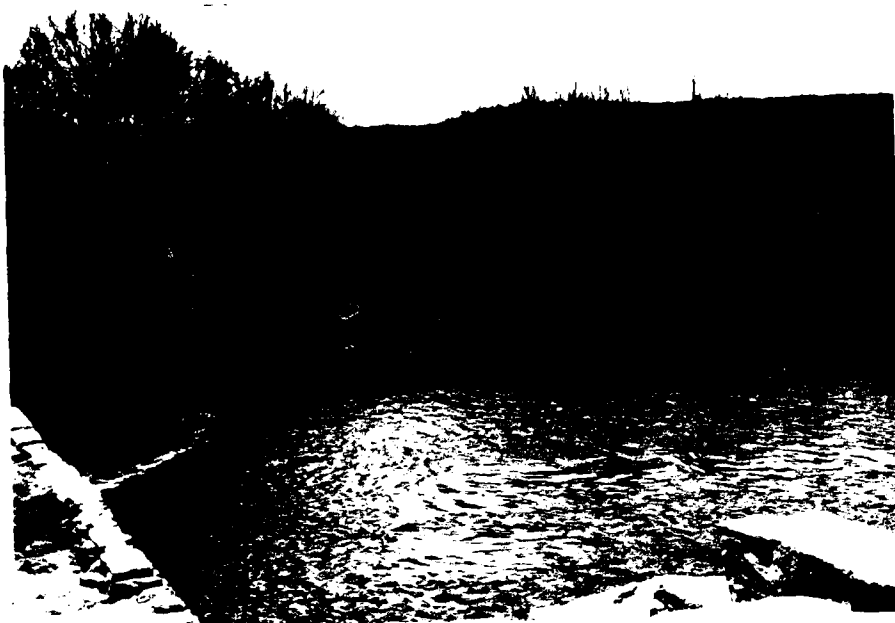
The left spillway training wall is a vertical stone masonry wall with mortared joints to a distance of about 50 feet upstream from the spillway crest. At this point the wall changes to unmortared stone masonry. Much of the pointing is missing from between the stones in the vertical masonry section, and a large stone is missing from the wall about 2 feet above the channel floor and 5 feet downstream from the spillway crest. There are trees growing in and overhanging the downstream spillway channel along the left training wall about 100 feet downstream from the spillway crest, as shown in the extreme left of Photo C-7.

C-7 Downstream Channel.

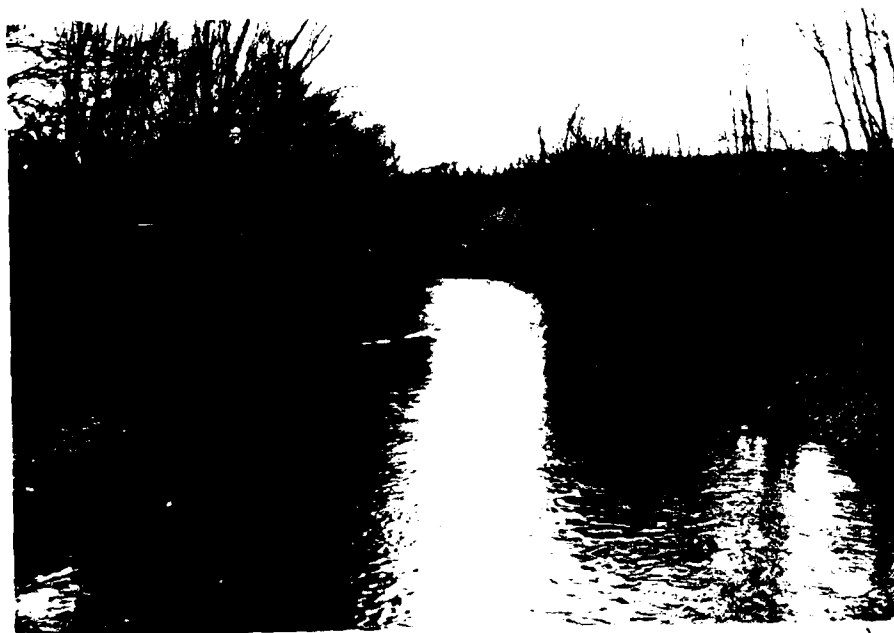
C-8 Downstream Channel below bridge.

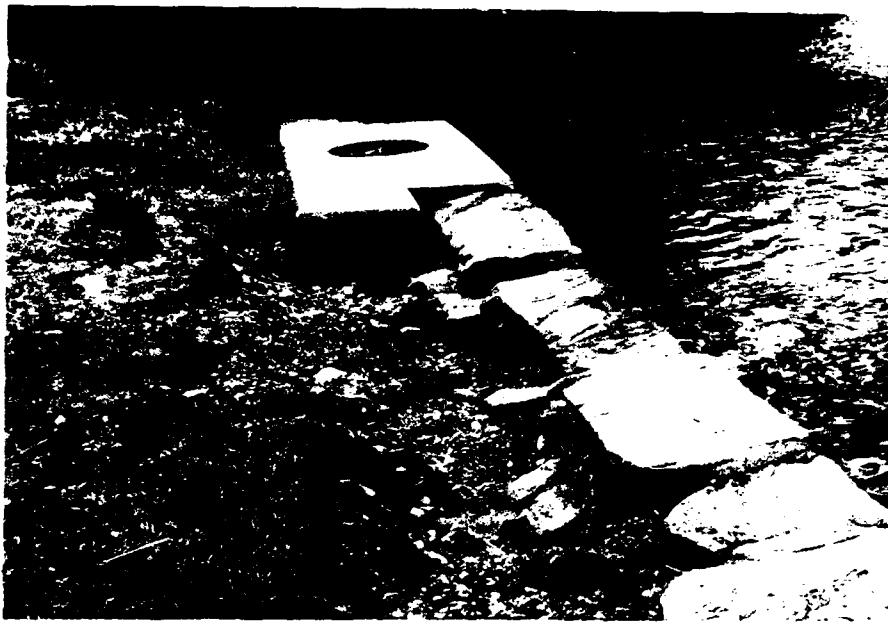
C-11 Erosion behind left training wall downstream of spillway, (manhole is sewer outfall).
